Sanderling Condominium Association

Roof Replacement

Centreville, VA

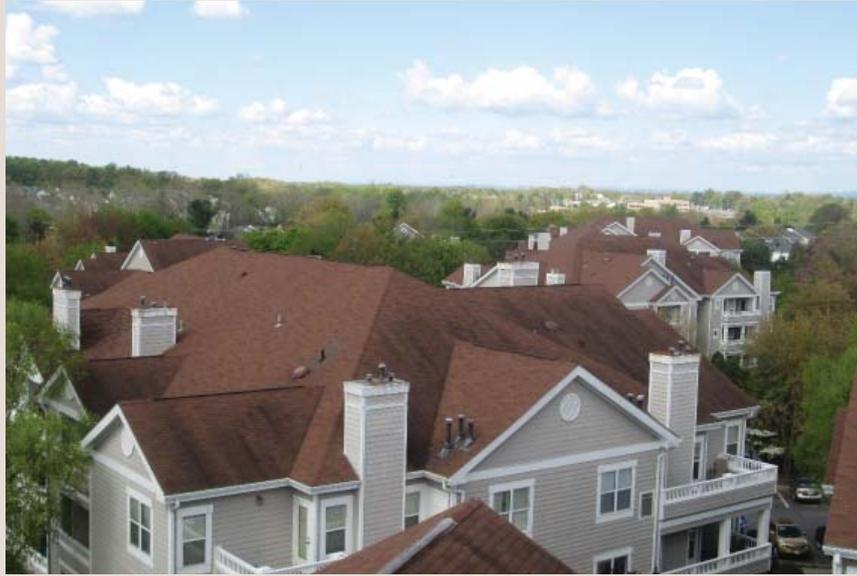
Before

The community had experienced roof related issues related including water infiltration as well as uncontrolled stormwater being discharged off the roofs. As part of the evaluation, it was determined that improvements to the attic ventilation and roof flashing details would be required to address the roof issues and that improvements to the gutters and leaders were necessary to enhance stormwater control. To improve leak protection at the step walls of the roof, self-adhered membranes (ice & water shield) are specified along the horizontal roof surface and along the adjacent vertical walls. Upon completion of the project, Falcon was able to successfully address the roof related issues that the community had previously experienced.

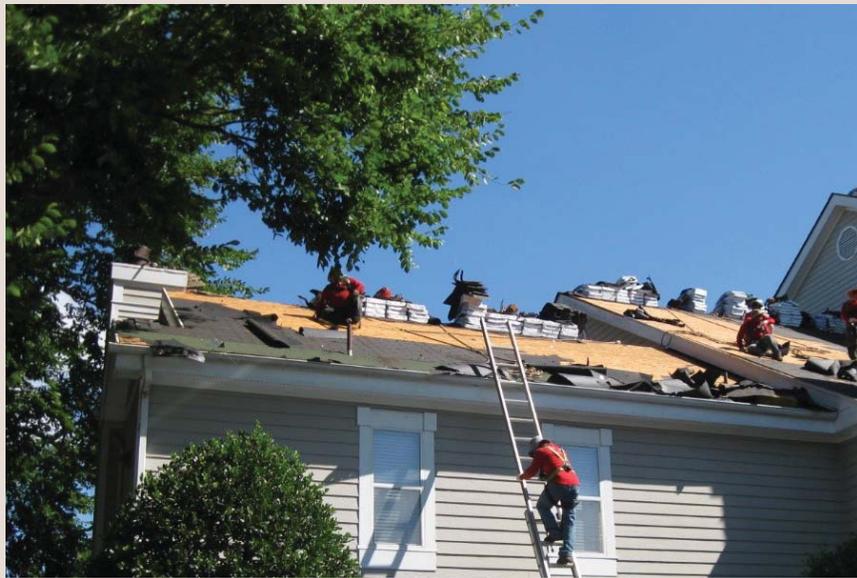
During the project, Falcon discovered that the condition of the existing composite wood siding was in poor condition and could not easily be removed and reinstalled without essentially destroying the element. Based on the existing poor conditions of the siding, Falcon proposed an alternate detail that would eliminate the need to temporarily remove the siding while still installing the leak protection. Ultimately, with the approval of the Association and per the proposed alternate detail, the existing wood siding was saw cut along and above the roofline enough to facilitate the installation of the sidewall flashing membrane without impacting a larger area of weak siding. Using the proposed alternate detail, the Association was still able to achieve the leak protection that the roofs desperately needed while keeping costs much lower than removing and replacing siding throughout.

Project includes the complete removal and replacement of roofing materials throughout the community. Additional work included replacement of the deficient roof decking, existing gutters and leaders, installation of flashing/ice shield membrane and attic ventilation improvements.
