Preventive Maintenance/Proper Reconstruction Protecting Assets, Ensuring Community Stability

By Andrew Amorosi, PE, RS

Building Finishing Systems: Time for a Check up?

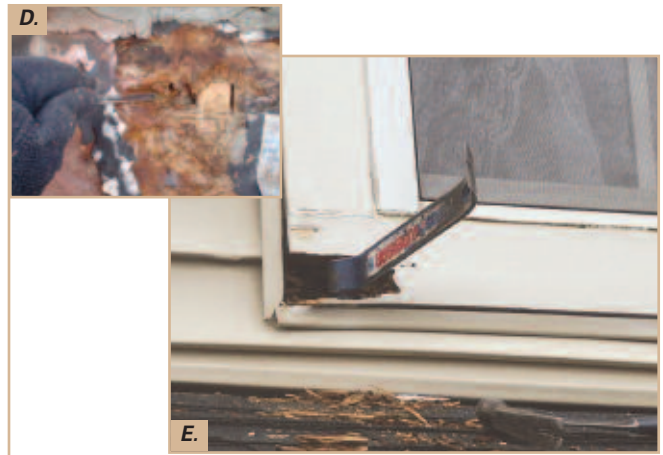
Figure D. Deteriorated building sheathing caused by water infiltration resulting from improper original veneer installation – this unit is only 3 years old.

Figure E. Deteriorated building trim can lead to structural damage and water infiltration. Improper original installation (priming or detailing), lack of caulk joint maintenance or lack of timely painting may cause this condition. Trim replacement can become an enormous expense if the community has significant amounts of building trim.

- **Siding and Trim** – Similar to the roof, these items make up a particularly common and important component of the PMP because of their aesthetics and function as a weather barrier. Depending on the type of siding, a program of painting, replacement and/or caulking may be necessary. **Figures D and E** illustrate the potential damage that can result from siding and trim problems.
- **Site drainage** – should begin at the building itself, with clean gutters and positive grades away from the buildings. The main drainage swales, culverts, basins and pipes should be periodically checked, and repaired as needed. **Figure F** illustrates the results of a problem caused by ineffective drainage.

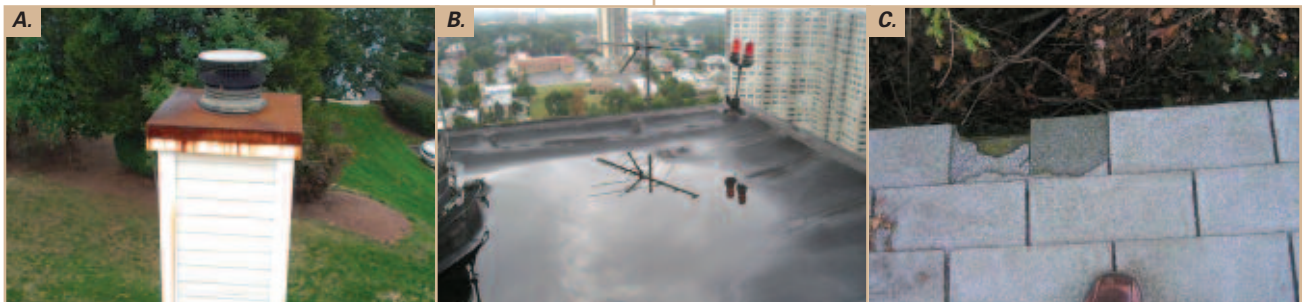
Figure A. Rusting or improper attachment of chimney caps can result in water infiltration into the building. **Figure B.** Ponding water on a flat roof will likely lead to leaks and structural damage. **Figure C.** Damaged or missing shingles can lead to water infiltration.

and inspection schedule. **Figures A, B, and C,** illustrate some of the visible indicators of roof deterioration.

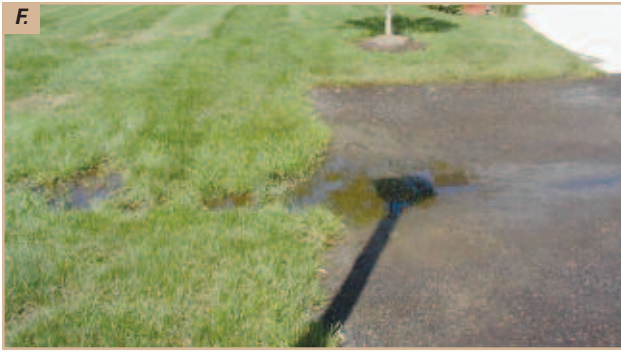
Figure F. Ponding water can deteriorate pavement, resulting in un-maintainable lawn areas while creating an insect breeding environment.

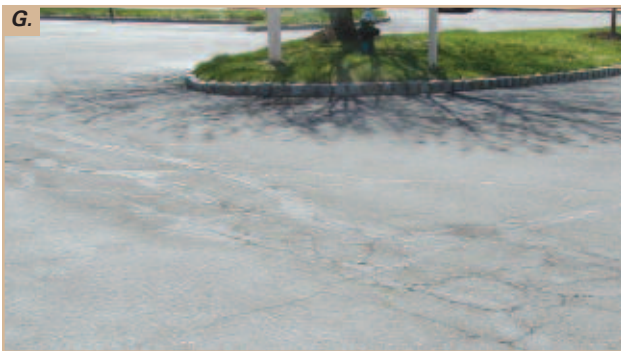
Figure G. Freeze/thaw cycles can cause severe pavement failures especially if cracks are not sealed prior to winter

- **Pavement** – should be inspected for cracks, settlement, and surfacing defects. Pavement will begin to deteriorate at an accelerated rate if there is no adherence to a proper preventive maintenance program. Water ponding, or entering, cracks, creates a serious problem. **Figure G** illustrates some visible signs of pavement deterioration.

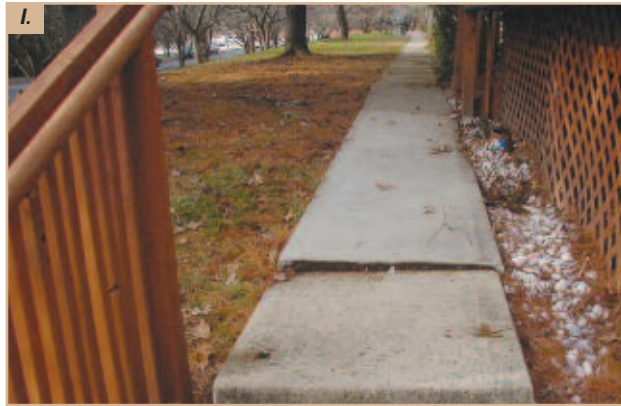
Figure H. Advanced deterioration of a parking structure, areas below and above the structural deterioration are not safe.

Figure I. Tripping hazards need to be alleviated with concrete replacement.

- **Concrete** – deficiencies which cause structural problems or tripping hazards should be replaced for safety, as well as liability prevention and aesthetic reasons. **Figures H** and **I** illustrate the visible signs of lack or proper concrete maintenance.
- **Recreational Areas/Clubhouses** – although perhaps not the most prominent component of the PMP, they may be the most important in terms of safety and liability. (See our related article in *Engineering Matters*, **Playground Safety**-

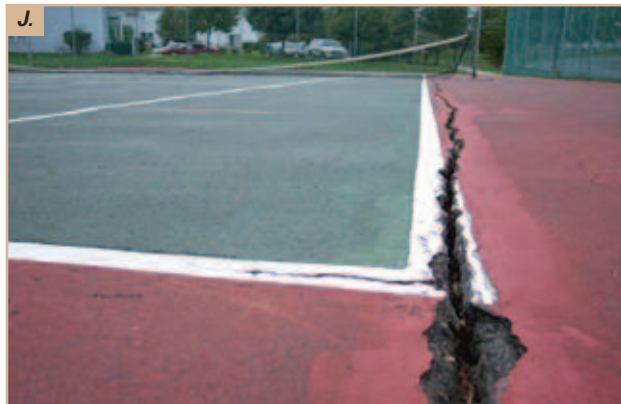
Figure J. Safety concerns for all recreation facilities and tot lots requires focus, attention and timely maintenance.

Not Just for Kids. Protect Your Children and Your Association, Volume 2, Issue 2). **Figure J** illustrates the deteriorated condition of a tennis court, making it less attractive to use, while introducing tripping and other safety hazards.

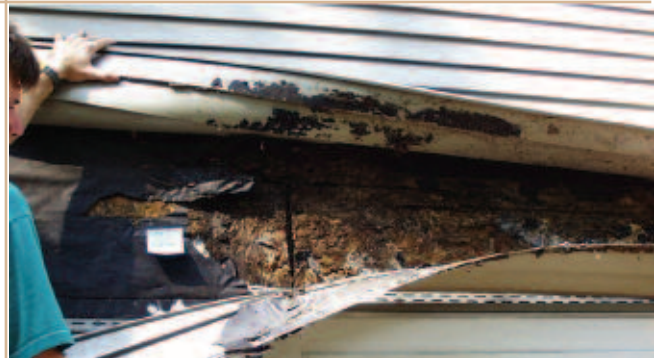
Unfortunately, siding may appear in good condition from the surface, however significant damage may exist behind the product.
