The Falcon Group

Dixon Mills Condominium Association

Roof Replacement

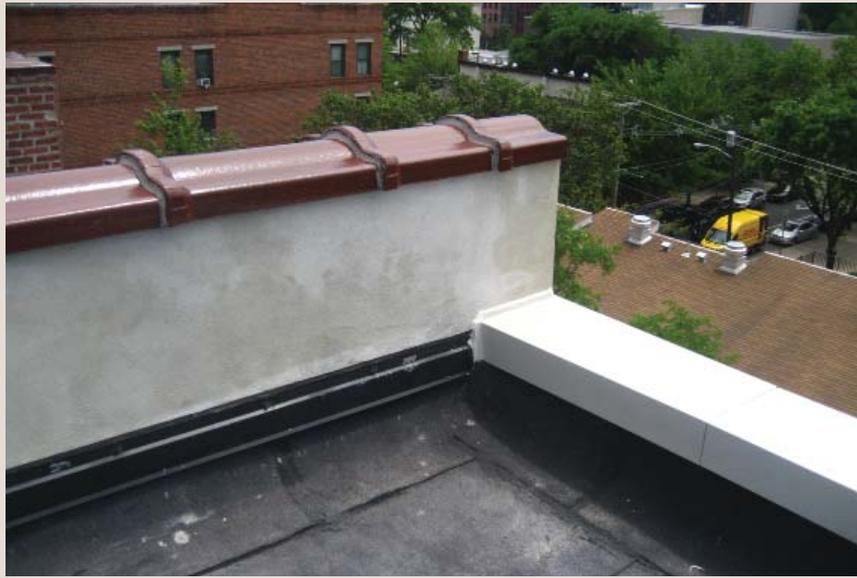
Before

This project included the complete removal and replacement of the existing low-slope modified bitumen roof system that was contributing to water infiltration in multiple units. The roof featured multiple different areas as well as separate, private terraces. All areas were replaced as part of this project and new wood framed terraces were installed at the private areas. Several large HVAC units that feed the common building areas were disconnected, lifted and placed on appropriate roof curbs. In addition to the roofing work, the masonry parapets also were addressed due to existing deficiencies. Because this building is in a Historic District, all materials and products that could be seen from the street needed approval from the Historic Preservation Office.

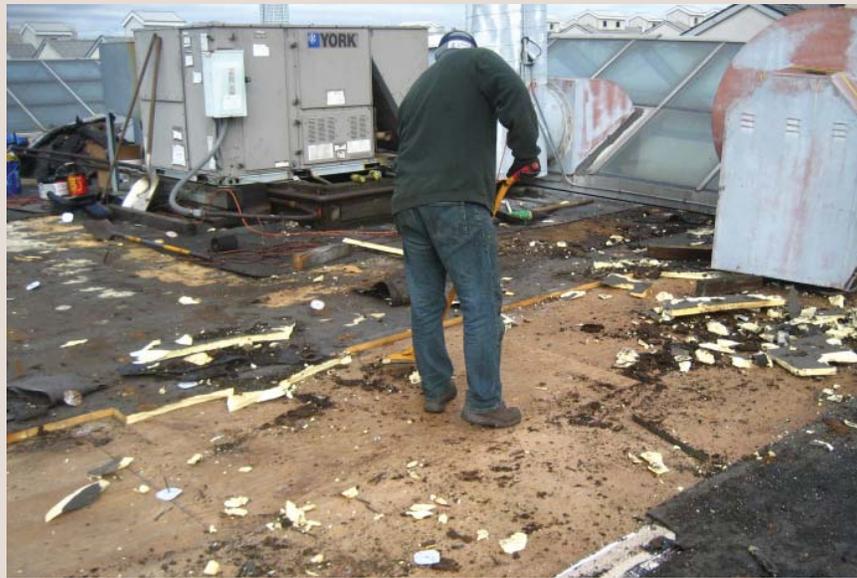
During

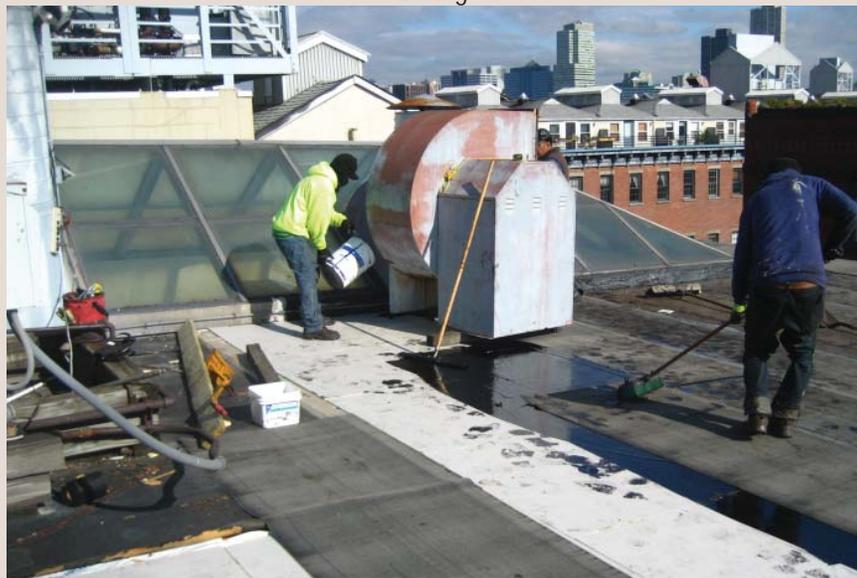
In Progress
