# The Falcon Group

## *Liberty Point Condominium Association*

### *Roof Replacement*

Jersey City, NJ

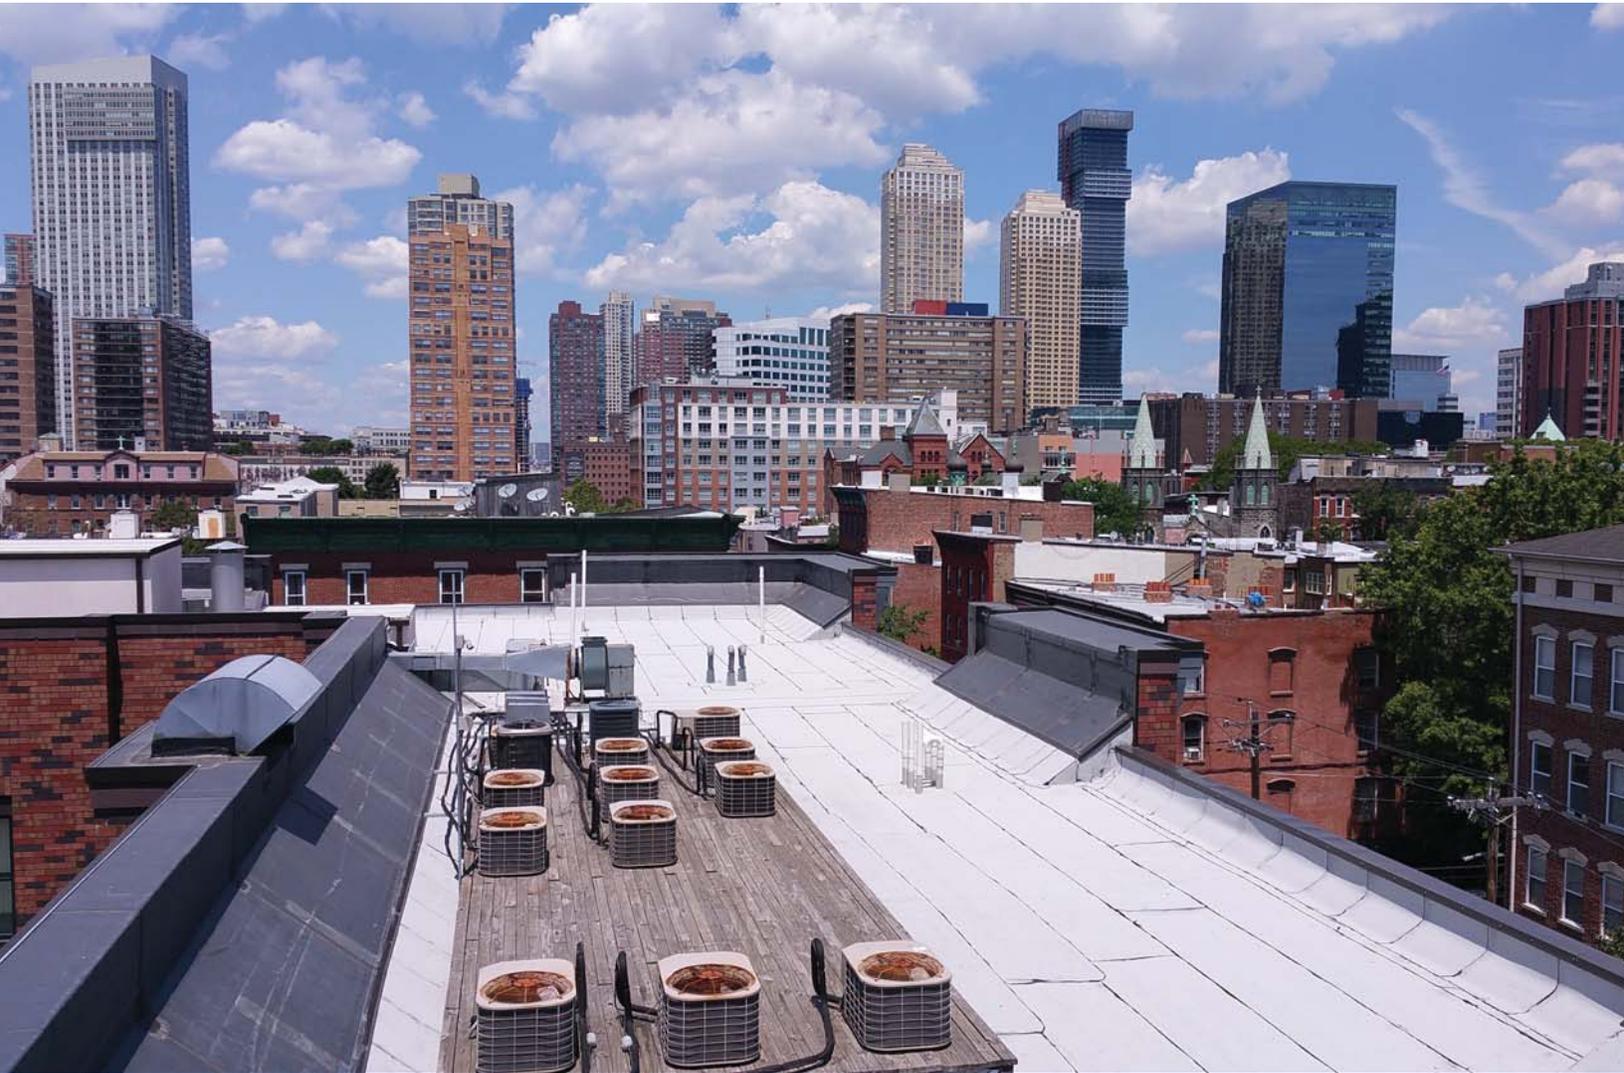
This project included the complete removal and replacement of the existing low-slope modified bitumen roof system. The roof consists of one large main roof area with several smaller stair tower bulkhead roofs.

The new roof system consisted of a multiply torch applied modified bitumen membrane installed over a full tapered rigid insulation system to eliminate previous areas of standing water due to insufficient deck slope.

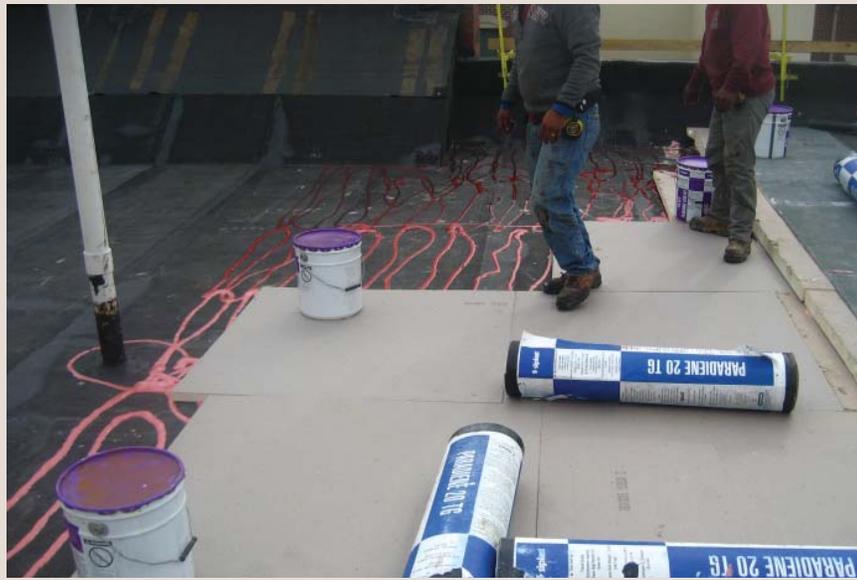
During

There are three (3) very large platforms on the roof where all the resident AC condenser units are located. The project required all these units to be disconnected so that they can be moved out of the way to allow for the roofing to be installed underneath.

The biggest challenge for this project was all the logistical work associated with the moving the HVAC units at the same time as the roofing work. Most of the AC units were disconnected before the project even started which meant that many of the residents would be without air conditioning.

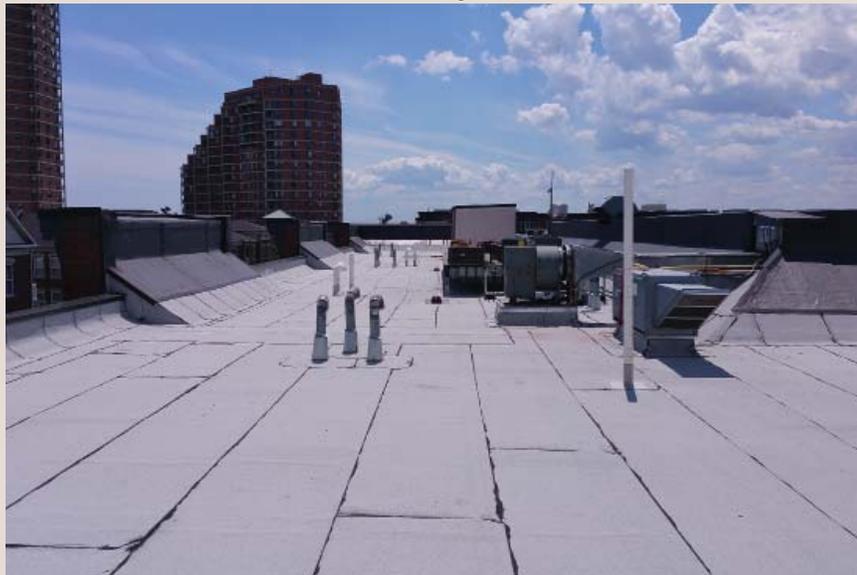
After

The multi-ply modified bitumen system was selected as it provides a very durable surface considering that there will be routine maintenance taking place on all the mechanical units present at the roof level.
