Grandover Pointe

Building Envelope Replacement

Wayne, NJ

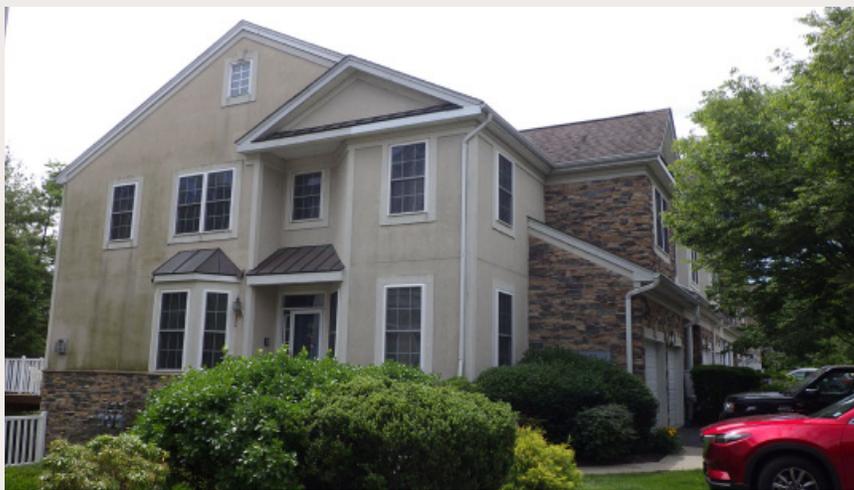
Before

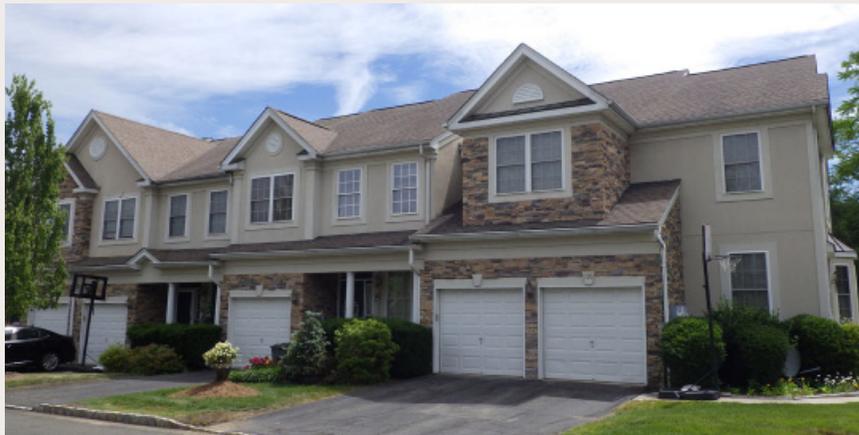
Before

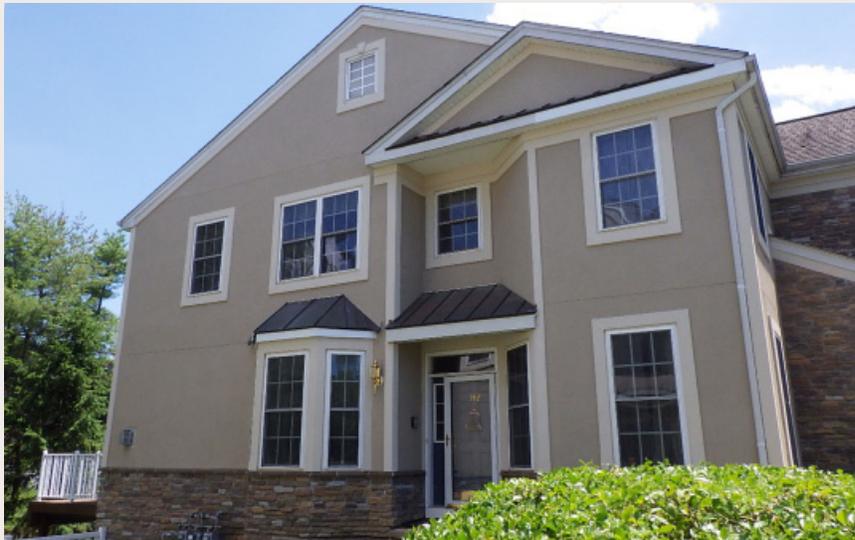
After

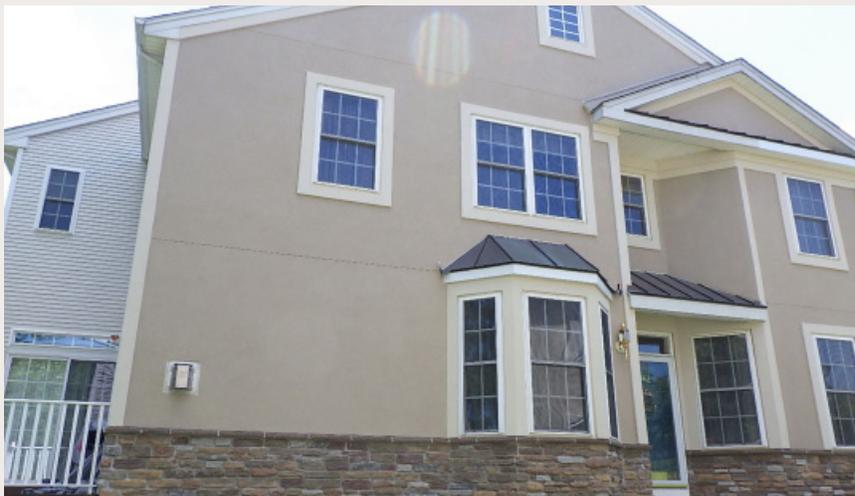
After
