## Deck/Balcony Replacements Condition assessments are critical for safety

By James Milito, AIA, Falcon Engineering and Architecture

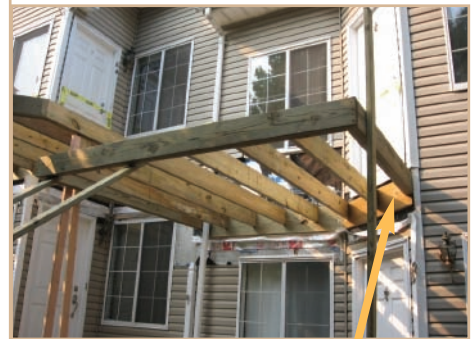
occur at the ledger to rim joist connection, the location where the deck attaches to the building.

*Deck ledger to rim joist connection.*

Deck ledgers, should be screwed or preferably bolted to the building rim joist—not merely nailed. Bolts and screws can resist the expansion and contraction of the wood. They may however, loosen over time. Early signs that deck ledgers are loosening creates a gap between the house and deck. If nails were used, the deck may fail without warning from the repeated expansions and contractions.

Proper spacing and type of lag bolt is equally important. In a June 2003 deck collapse in Chicago, 13 people were killed and 40 people were injured. Some of the victims were below the deck that collapsed. Research into the event found that lag bolts were installed, however, they were spaced too far apart and bent prior to the collapse.
